Owner: Direction des Travaux Publics de la Wilaya  
Design Engineer: COWI A/S  
Consultant Engineer: Dar al Handasah  
Foundation Contractor: Trevi SpA  
Location: **Project Description:**

The Constantine Viaduct is a new bridge crossing the River Rhumel in Constantine, Algeria. Constantine is situated on a plateau at 640 metres above sea level with the city framed by a deep ravine and having a dramatic appearance due to a number of bridges and viaduct crossing the valley.

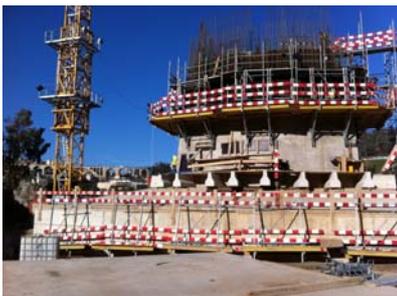
Pier under construction

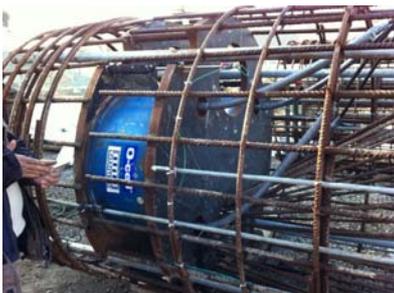
O-cell assembly

In order to verify the original Limestone rock socket and the concept of the new foundation design, O-cell bi-directional tests were undertaken on both sides of the ravine on 2000 mm diameter working piles. Twin 870 mm O-cells were installed in the pile reinforcement approximately 1 m above the toe of each pile. The first, into the rock socket, was 46 m deep and the second in the Marlstone 27 m long.

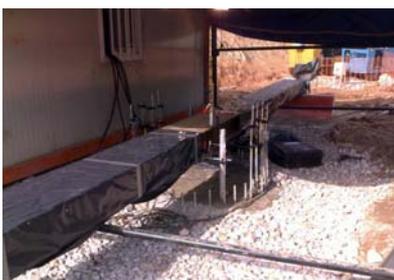
O-cell bi-directional testing setup

A maximum gross load of approximately 40 MN in each direction was applied. Strain gauges and mechanical extensometers were used to measure the skin friction distribution.
