STAR-ORION SOUTH DIAMOND PROJECT

PRINCE ALBERT, SASKATCHEWAN, CANADA

CASTING PIT FACILITY

MICHIGAN, USA

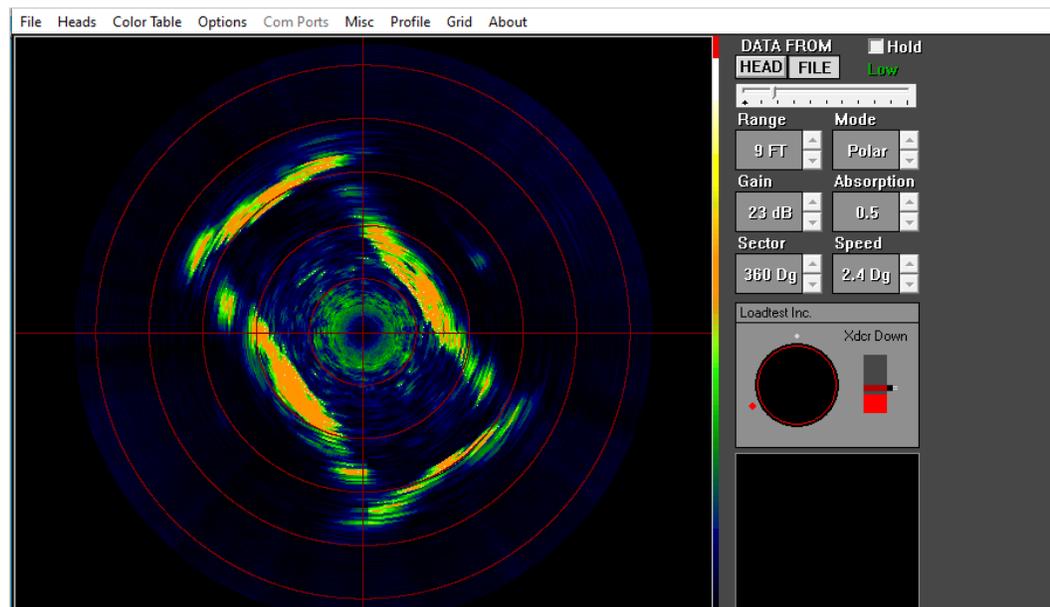
SONICaliper's real-time results

SONICaliper measurements, calibrated to known dimensions at the surface, proceeded at general 4-foot vertical spacings until the vein of interest was reached when the measuring interval became a 2-foot spacing. Performed in November 2019 these hydro-mill panels are the deepest ever profiled by SONICaliper.

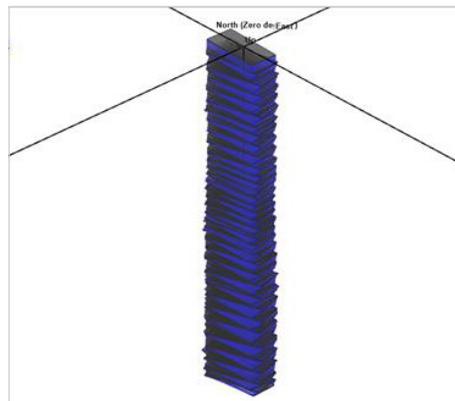
Excavation model

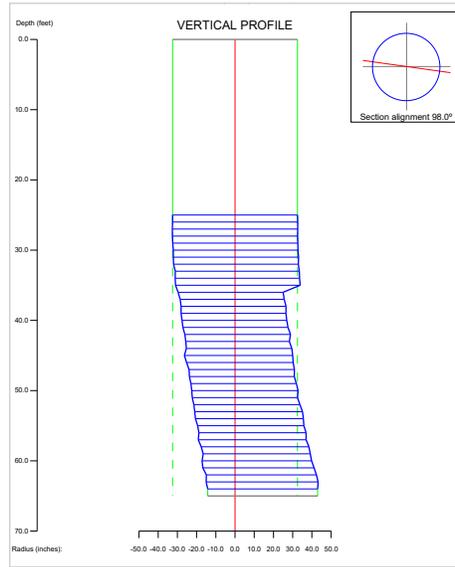
Figure 1 – SONICaliper profile - pass 1

The initial two SONICALIPER passes revealed that the auger had wandered more than 18

inches off-center as drilling progressed.

Figure 1 shows the existing excavation cross-section from these initial inspection passes. As this was a feature for the existing facility, moving the location and starting over was not an option; the excavation had to be remediated.

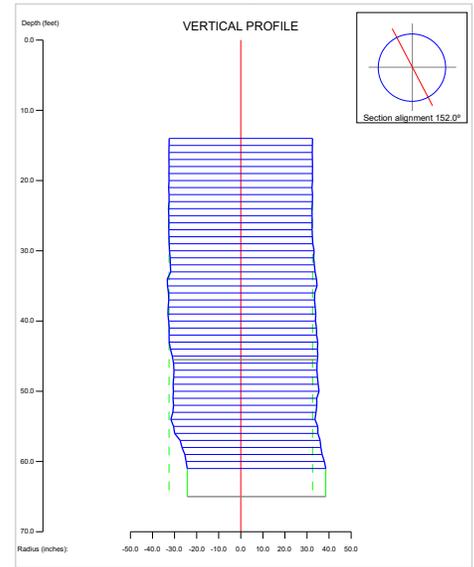
Figure 2 – SONICaliper profile - pass 3

verticality was improving to specified requirements. Figures 2 and 3 show the verticality remediation improvements.

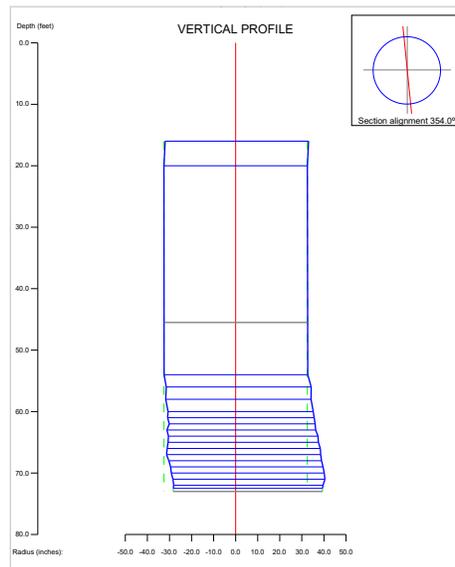
Figure 3 – SONICaliper profile - pass 6

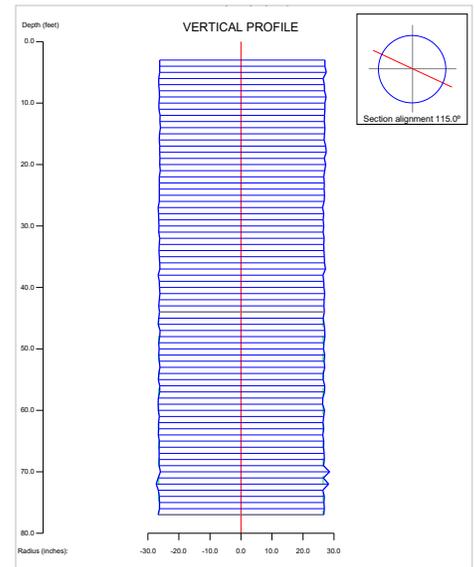
Figure 4 – SONICaliper profile – grout monitoring
