Case study

Fugro LOADTEST have performed shaft profiling using the patented SONICaliper system to a European record depth of 292.6 m

Sirius Minerals Polyhalite Mine

Mineral Transport Systems  
Lockwood Beck

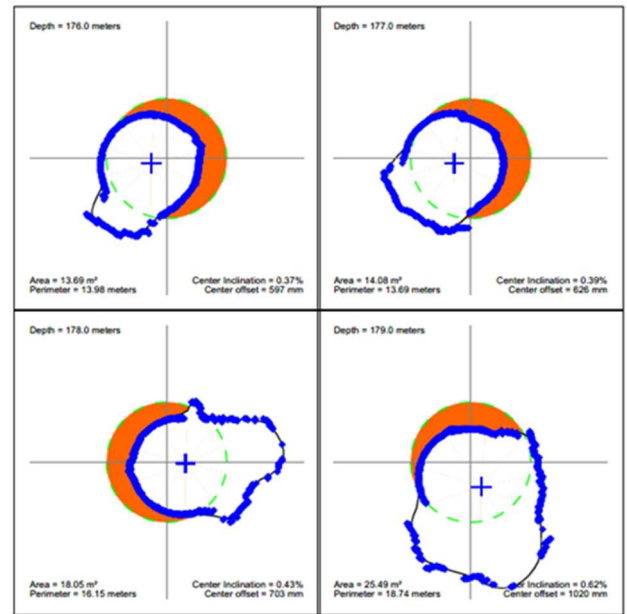
2-D Data Rings with polynomial assessment Indicated shaft wall collapse at 176 – 179 m Depth.

The SONICALIPER successfully imaged the area of shaft wall collapse and provided estimates for actual shaft volume. Rapid mobilisation of equipment combined with immediate site reports enabled pro active management of conditions, and swift implementation of remediation plans using the information provided.

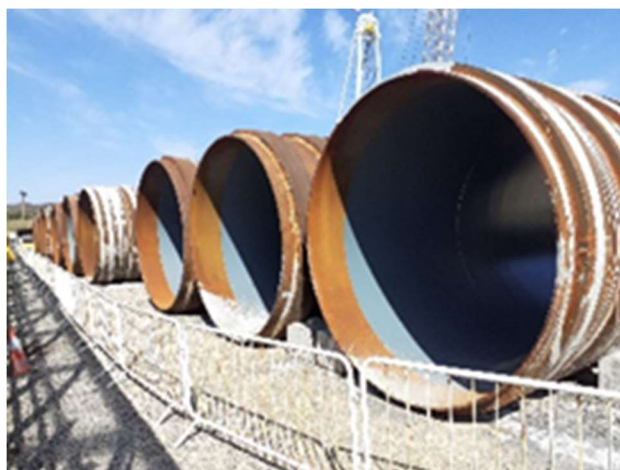
Shaft casings ready for installation

Quality assurance that remediation works were effective provided the client with greater confidence to proceed with the final installation of casing, minimising delay and disruption to the progress of the MTS.
